**Flood Control Project Maintenance
Levee Inspections**

Fall 2016 Levee Maintenance Deficiency Summary Report

**Flood Control Project Maintenance
Levee Inspections**
LMA District Cover Sheet
Fall 2016 Levee Inspection Results

Reclamation District No. 0501 Ryer Island

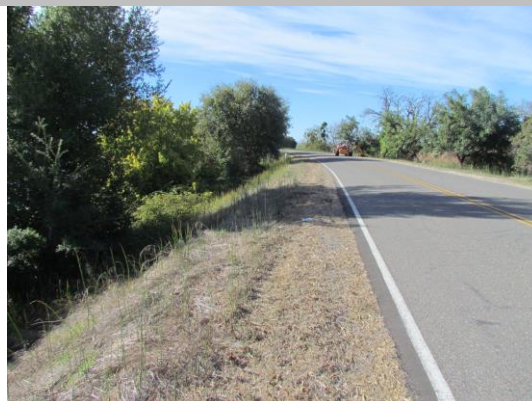
Photo 1 of 1 : FA_2016_RD0501_169_44_20161021_00060.jpg

LM Start	0.04	Rating **	M	Issue No.	44
LM End	2.81	Issue Type +	Ma	Location *	WS
Category	Earthen Levee			GPS Latitude/Longitude	
				Start	End
Item	Vegetation			38.254035 °	38.215490 °
				-121.601790 °	-121.607930 °
DWR ID	DWR_RD0501_01_f_2016_44				
Comment Code					
V2 : Remove the wild growth other than native grasses from the levee slopes.					
Inspector Comment					
RD is mowing the landside slope once that's done they will start on the waterside slope, right now there are still tall weeds that were not mowed during this inspection.

RD 501 LOOKING DOWNSTREAM levee mile 0.04-2.68.

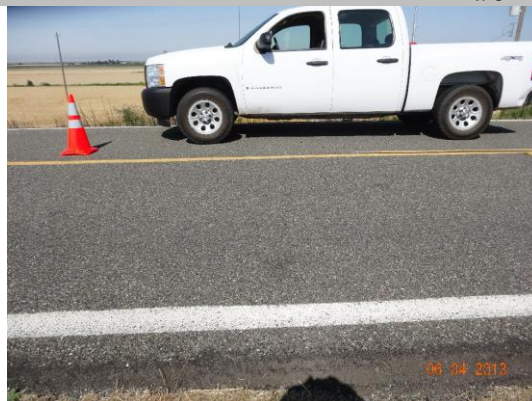
Photo 1 of 2 : UCIP_FA_2016_32524_58928.jpg

Comment Code					
Inspector Comment					
FS_ID:32524					
DS_ID:21031					
EP_NO: N/A					
Repair Type: Non-Urgent					
Crossing Status: Found					
UCIP Comments: Dense vegetation limits the inspector's visibility to identify signs of leaks through the slope. Recommend removing vegetation along pipe alignment for reinspection. Need to contact the owner to clear slope along crossing.					
FIELD_STRUCT_DESC: 20-inch and 2.5-inch pipes through the levee, both 7.8 feet below the crown. Pump in pump house on landward slope. Pipe exposed along waterward slope. (USACE-1959). This entry matches the Drainage or Irrigation Structure referenced in O&M manual (HLM 0.40).					
FS Date: 6/4/2013

View of crown

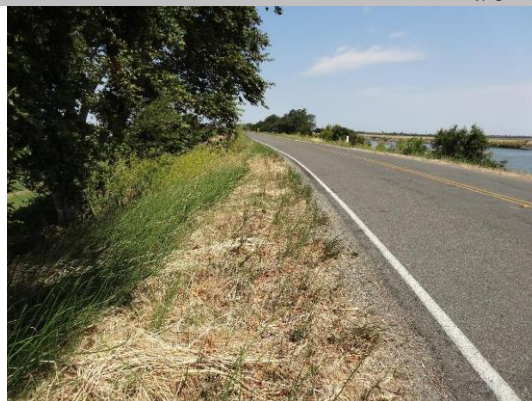
Photo 1 of 2 : UCIP_FA_2016_50020_75648.jpg

FS_ID:50020
DS_ID:21034
EP_NO: N/A
Repair Type: Non-Urgent
Crossing Status: Found
UCIP Comments: 8/22/2016 Crossing has been downgraded from Urgent to Non-Urgent -- no evidence of damage to levee is present. Dense vegetation limits the inspector's visibility to identify signs of pipe failure (leaks) through the slope. Recommend removing vegetation along pipe alignment to conduct proper inspection of structure and appurtenances. Also will need to coordinate with owner to determine if permit was obtained for the modifications made to crossing (PVC pipe sleeved through existing pipe). (DWR UCIP - omagana)4/21/2015 Unauthorized PVC pipe. Annular space not grouted. 14-inch pipe open on both ends. (DWR UCIP - omagana)
FIELD_STRUCT_DESC: 14-inch steel irrigation pipe through the levee, 3.2 feet below the crown. 10-inch polyvinyl chloride (PVC) pipe sleeved through 14-inch with a siphon breaker located on the landside (LS) shoulder. [Additional Reference(s): DWR Levee Log, 1980 and 2005. USACE Sacramento O&M Manual Unit No. 105, April 1959, (HLM 1.0)].

View of levee crown and LS shoulder.

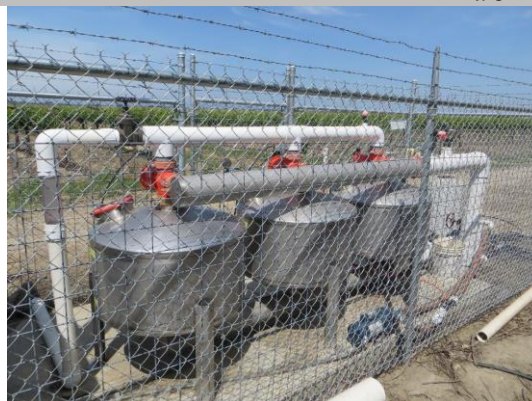
Photo 1 of 2 : UCIP_FA_2016_47516_73857.jpg

FS_ID:47516
DS_ID:21086
EP_NO: 13233
Repair Type: Non-Urgent
Crossing Status: Found
UCIP Comments: Annular space between pipes not grouted. FPIIB Inspector Herman Phillips will contact owner regarding lack of permit for sand filters. Steel plate partially covers openings between pipes.
FIELD_STRUCT_DESC: 14-inch steel pipe through the levee, 2.5-feet below the crown. Cutoff wall around pipe at center of levee. Pump and check valve in pump house on waterward slope. Service pole on landward slope. (Permit No. 13233-1982) 8-inch steel irrigation pipe sleeved through 14-inch (under Permit No. 11813-1, 2013). A 1.5 and a 2.5-inch electrical conduit at same location. Siphon breaker on both shoulders.
FS Date: 4/21/2015

Sand filter plant on LS toe.

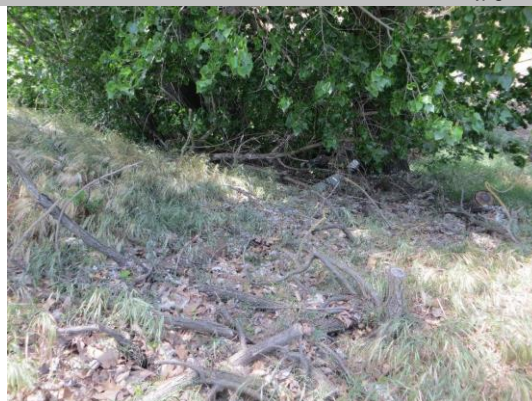
Photo 1 of 2 : UCIP_FA_2016_44683_73882.jpg

LM Start	2.34	Rating **	M	Issue No.	987
LM End	2.34	Issue Type +	En	Location *	LS
Category	Supplemental			GPS Latitude/Longitude	
				Start	End
Item	DWR UCIP Field Study			38.221277 °	38.221277 °
				-121.603505 °	-121.603505 °
DWR ID					
Comment Code					
Inspector Comment					
FS_ID:44683 DS_ID:21021 EP_NO: N/A Repair Type: Non-Urgent Crossing Status: Found UCIP Comments: Appears abandoned and if so should be done so properly. Discarded pipe on WS slope should be removed. FIELD_STRUCT_DESC: 10-inch steel irrigation pipe through the levee, 2.5-feet below the crown. Pump and gate valve in pump house on waterward slope. a 4'X4' concrete distribution box, power pole, and meter on LS toe (USACE-1959). This entry matches the Drainage or Irrigation Structure referenced in O&M manual (HLM 2.50). FS Date: 4/21/2015

Pipe visible on LS slope.

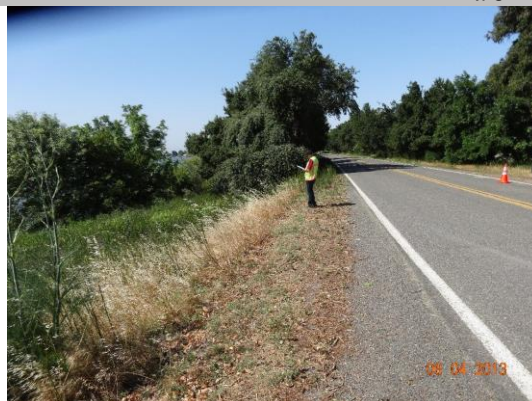
Photo 1 of 2 : UCIP_FA_2016_32526_58933.jpg

Overview of crown at crossing, looking downstream.

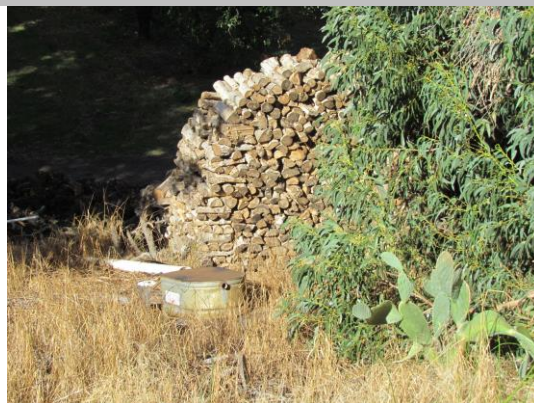
Photo 1 of 3 : FA_2016_RD0501_169_63_20161021_00061.jpg

LM Start	3.24	Rating **	U	Issue No.	63
LM End	3.24	Issue Type +	En	Location *	LS
Category	Earthen Levee			GPS Latitude/Longitude	
				Start	End
Item	Encroachments			38.209811 °	38.209713 °
				-121.610813 °	-121.610882 °
DWR ID	DWR_RD0501_01_f_2012_63				
Comment Code					
MA : Material					
Inspector Comment					
There is a large stock pile of fire wood, metal scrap, and other unwanted materials placed withn the 10-foot easement landside that ned to be removed.

RD 501 Unit 1 levee mile 3.24 landside slope and toe.

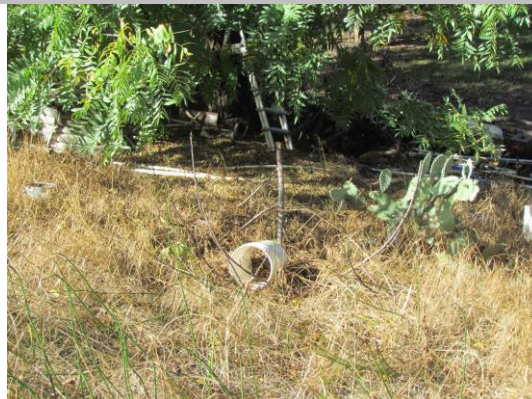
Photo 3 of 3 : FA_2016_RD0501_169_63_20161021_00063.jpg

LM Start	3.24	Rating **	U	Issue No.	63 (cont)	
LM End	3.24	Issue Type +	En	Location *	LS	
Category	Earthen Levee			GPS Latitude/Longitude		
				Start		End
Item	Encroachments			38.209811 °		38.209713 °
				-121.610813 °		-121.610882 °
DWR ID	DWR_RD0501_01_f_2012_63					
Comment Code						
MA : Material						
Inspector Comment						
There is a large stock pile of fire wood, metal scrap, and other unwanted materials placed withn the 10-foot easement landside that ned to be removed.

RD 501 Levee mile 3.24 landside toe.

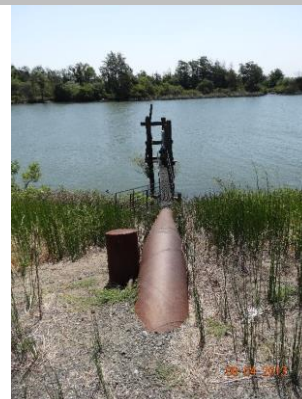
Photo 2 of 2 : UCIP_FA_2016_32529_58951.jpg

View of waterward side--siphon breaker, walkway, platform, pump, and control panel.

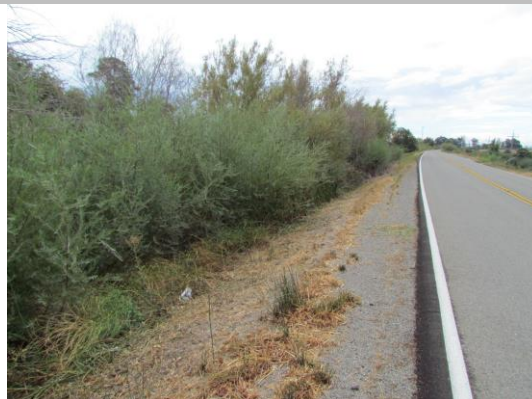
Photo 1 of 1 : FA_2016_RD0501_169_974_20161018_00012.jpg

LM Start	3.73	Rating **	U	Issue No.	974
LM End	4.12	Issue Type +	Ma	Location *	WS
Category	Earthen Levee			GPS Latitude/Longitude	
				Start	End
Item	Vegetation			38.202997 °	38.197778 °
				-121.613450 °	-121.616080 °
DWR ID	DWR_RD0501_01_s_2012_974				
Comment Code					
V2 : Remove the wild growth other than native grasses from the levee slopes.					
Inspector Comment					
Remove the wild growth from the waterside slope.

Unsatisfactory wild tree growth on the waterside slope. No new photo.

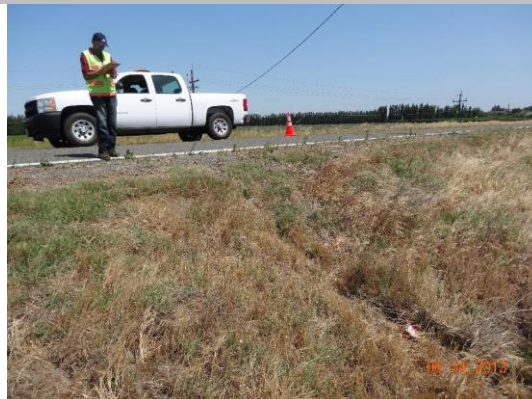
Photo 1 of 2 : UCIP_FA_2016_19644_33328.jpg

View of waterward side.

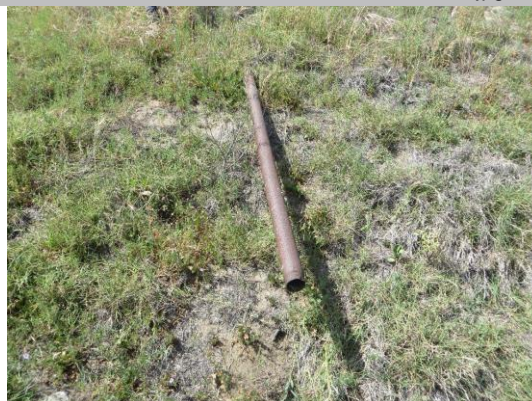
Photo 1 of 2 : UCIP_FA_2016_50024_73901.jpg

2.5-inch conduit visible on WS slope.

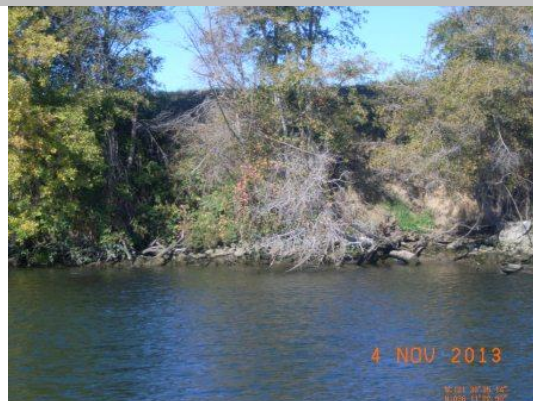
Photo 1 of 1 : FA_2016_RD0501_169_1_20161018_00001.jpg

LM Start	5.77	Rating **	M	Issue No.	1
LM End	5.84	Issue Type +	Ma	Location *	WS
Category	Supplemental			GPS Latitude/Longitude	
				Start	End
Item	2015 USACE Erosion Survey, DRAFT			38.190001 °	38.189311 °
				-121.643160 °	-121.643917 °
DWR ID	DWR_RD0501_01_f_2016_1				
Comment Code					
Inspector Comment					
2008 - Overstepped levee section with multiple small pockets of erosion 10 - 20 ft wide. 2013 - Site has fresh erosion and taller vertical sections. 2015: No observed changes. [2015 Site ID: STM_15-7_R]

USACE 2013 Photo #1

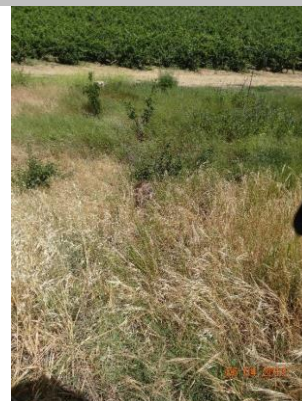
Photo 1 of 2 : UCIP_FA_2016_32530_58957.jpg

Abandoned 16-inch pipe on landward side.

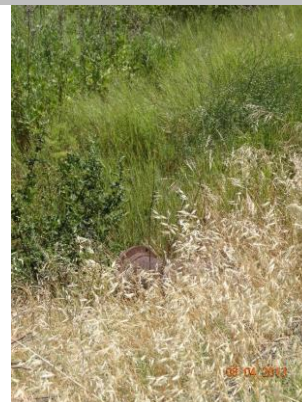
Photo 2 of 2 : UCIP_FA_2016_32530_58956.jpg

Overview of waterward side--section of pipe visible through dense vegetation.

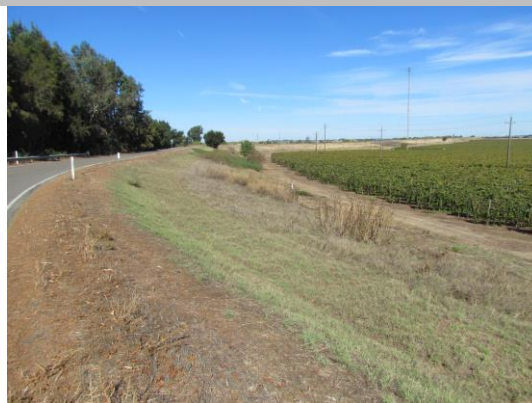
Photo 1 of 1 : FA_2016_RD0501_170_24_20161024_00043.jpg

LM Start	0.01	Rating **	A	Issue No.	24
LM End	3.55	Issue Type +	Ma	Location *	LS
Category	Earthen Levee			GPS Latitude/Longitude	
				Start	End
Item	Vegetation			38.184110 °	38.227787 °
				-121.658015 °	-121.673103 °
DWR ID	DWR_RD0501_02_f_2016_24				
Comment Code					
V1 : Control annual grass and weeds on the levee slopes and easements.					
Inspector Comment					
The RD is mowing the landside levee slope and toe during this inspection.

RD 501 Unit 2 levee mile 0.00 -3.55 landside looking downstream of levee slope.

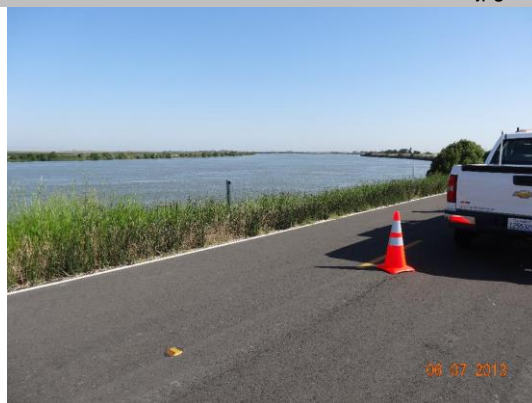
Photo 1 of 2 : UCIP_FA_2016_32531_58960.jpg

Comment Code					
Inspector Comment					
FS_ID:32531 DS_ID:21035 EP_NO: N/A Repair Type: Non-Urgent Crossing Status: Found UCIP Comments: Dense vegetation limits the inspector's visibility to identify signs of pipe failure (leaks) through the slope. Recommend removing vegetation along pipe alignment to conduct proper inspection of structure and appurtenances. Need to determine owner and status of crossing. FIELD_STRUCT_DESC: 10-inch pipe sleeved through a 12-inch pipe through the levee, 5.0 feet below the crown. Pump on waterward side. (USACE-1959). This entry matches the Drainage or Irrigation Structure referenced in O&M manual (HLM 0.60). FS Date: 6/7/2013

View of crown.

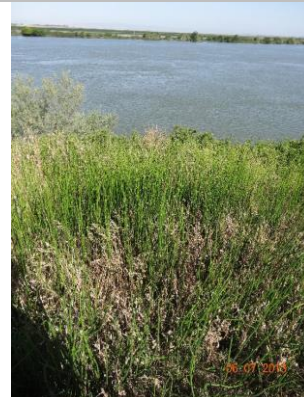
Photo 2 of 2 : UCIP_FA_2016_32531_58958.jpg

Comment Code						
Inspector Comment						
FS_ID:32531						
DS_ID:21035						
EP_NO: N/A						
Repair Type: Non-Urgent						
Crossing Status: Found						
UCIP Comments: Dense vegetation limits the inspector's visibility to identify signs of pipe failure (leaks) through the slope. Recommend removing vegetation along pipe alignment to conduct proper inspection of structure and appurtenances. Need to determine owner and status of crossing.						
FIELD_STRUCT_DESC: 10-inch pipe sleeved through a 12-inch pipe through the levee, 5.0 feet below the crown. Pump on waterward side. (USACE-1959). This entry matches the Drainage or Irrigation Structure referenced in O&M manual (HLM 0.60).						
FS Date: 6/7/2013

Overview of waterward side. Inaccessible due to dense vegetation.

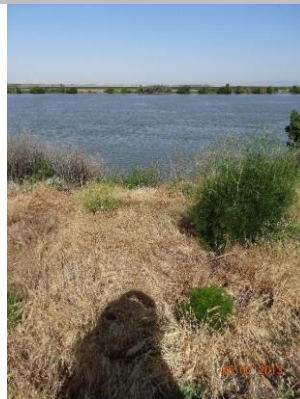
Photo 1 of 2 : UCIP_FA_2016_50018_58967.jpg

Overview of WS--20 foot berm present.

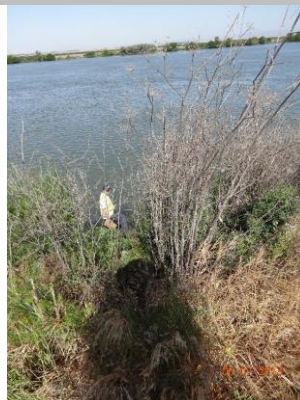
Photo 2 of 2 : UCIP_FA_2016_50018_58965.jpg

View of WS. Inspector is standing near exposed section of pipe at levee toe.

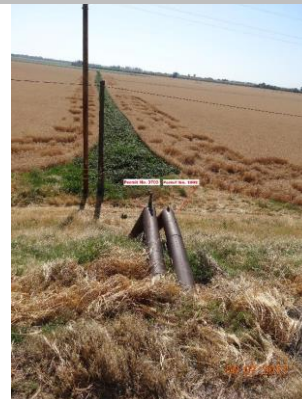
Photo 1 of 2 : UCIP_FA_2016_50019_58968.jpg

8-inch pipes approximately 1 foot apart.

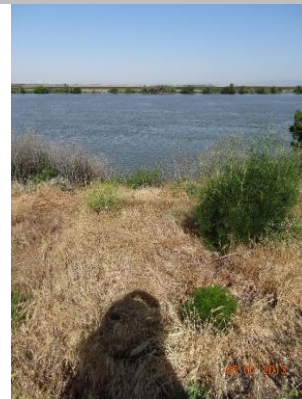
Photo 2 of 2 : UCIP_FA_2016_50019_58970.jpg

Comment Code					
Inspector Comment					
FS_ID:50019 DS_ID:21036 EP_NO: 1902 Repair Type: Urgent Crossing Status: Found UCIP Comments: 8/22/2016 Same as previous inspection. Pipe is deteriorating and open on WS. (DWR UCIP - omagana)6/07/2013 Reason for an Urgent Priority is due to adjacent crossing--adjacent crossing has holes present and is was installed in the 1960s. Our records show this pipe was installed before 1955. Dense vegetation limits the inspector's visibility to identify signs of pipe failure (leaks) through the slope. Recommend removing vegetation along pipe alignment to conduct proper inspection of structure and appurtenances. If crossing is no longer in use--Owner will need to coordinate with DWR Inspector and CVFPB. Need to determine condition of pipe--request maintenance records from owner once found-this crossing could be capped and grouted--NEED RECORDS. (DWR UCIP - omagana) FIELD_STRUCT_DESC: *ABANDONED* 8-inch steel irrigation pipe encased in a 10-inch 14 gage corrugated metal pipe through the levee, 1.7 feet below the crown. Siphon breaker on the apex of pipe located on the landside (LS) shoulder. Pipe discharges into concrete sump near LS toe. Pipe is exposed along LS slope. (original O&M 8-inch pipe section through levee was removed and replaced with a 8-inch steel pipe encased in 10-inch corrugated metal pipe under Permit No. 1902, 1959 - Enzo Guidi). [Additional Reference(s): DWR Levee Log, 1980 and 2005. USACE Sacramento O&M Manual Unit No. 105, April 1959, (HLM 0.90)]. FS Date: 8/22/2016

Overview of waterward side--20 foot berm present.

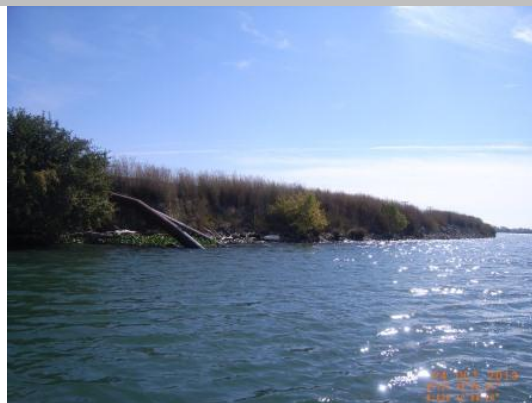
Photo 1 of 1 : FA_2016_RD0501_170_1_20161018_00001.jpg

LM Start	1.10	Rating **	M	Issue No.	1
LM End	1.17	Issue Type +	Ma	Location *	WS
Category	Supplemental			GPS Latitude/Longitude	
				Start	End
Item	2015 USACE Erosion Survey, DRAFT			38.199128 °	38.200146 °
				-121.655881 °	-121.655638 °
DWR ID	DWR_RD0501_02_f_2016_1				
Comment Code					
Inspector Comment					
2005 - Large vertical sections due to wave wash. New stone dumped on the bank with exposed geotextile. Cohesive toe has thin weak stratigraphic unit that is washing out. 2006 - Partially repaired, but 100 ft in the middle of the reach has exposed filter fabric and stone riprap is gone. 2010 - Site extended downstream to include new erosion pocket. 2015: No observed changes. [2015 Site ID: CHS_15-9_L]

USACE 2013 Photo #1

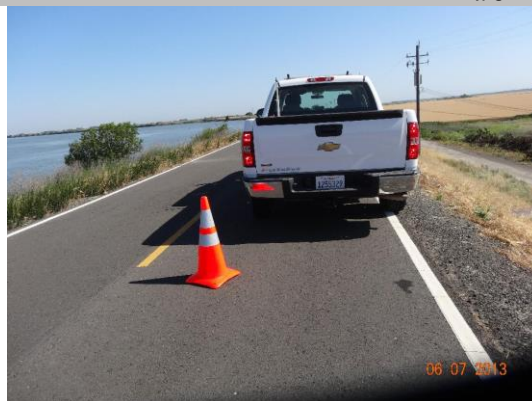
Photo 1 of 2 : UCIP_FA_2016_44865_58975.jpg

View of levee crown at crossings.

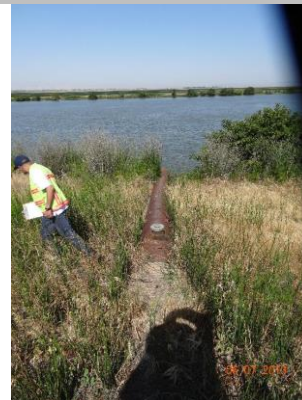
Photo 2 of 2 : UCIP_FA_2016_44865_58972.jpg

View of waterward side--pipe section exposed and siphon breaker. Over 20 feet berm on waterward side.

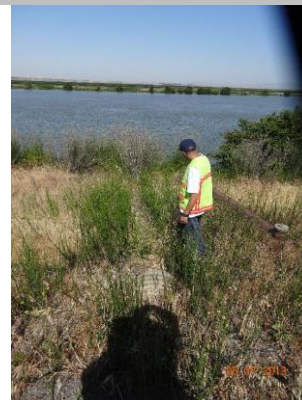
Photo 2 of 2 : UCIP_FA_2016_44866_58979.jpg

Two pipes on waterside.

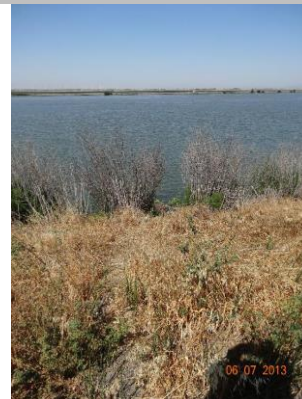
Photo 1 of 2 : UCIP_FA_2016_44867_58987.jpg

Comment Code						
Inspector Comment						
FS_ID:44867						
DS_ID:21093						
EP_NO: 13520						
Repair Type: Non-Urgent						
Crossing Status: Found						
UCIP Comments: Dense vegetation limits the inspector's visibility to identify signs of pipe failure (leaks) through the slope. Recommend removing vegetation along pipe alignment to conduct proper inspection of structure and appurtenances. Owner needs to be informed about the vegetation clearance required for proper inspection.						
FIELD_STRUCT_DESC: 18-inch steel pipe through the levee, 3.4 feet below the crown. Steel cutoff wall around pipe at center of levee.						
Siphon breaker on apex of pipe on landward shoulder. Pipe extends from sump off of landward toe. Pipe exposed along waterward slope.						
Rock revetment on waterward slope. (Permit No. 13520-1982)						
FS Date: 6/7/2013

Overview of waterside. Dense vegetation.

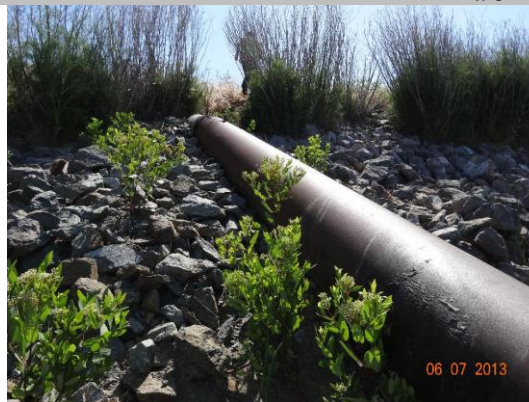
Photo 2 of 2 : UCIP_FA_2016_44867_58982.jpg

View of waterward side--pipe extends from berm to river.

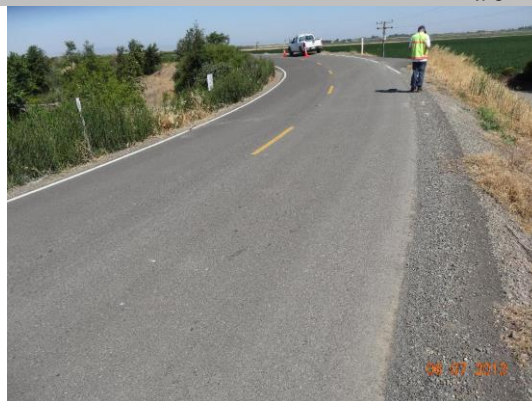
Photo 1 of 2 : UCIP_FA_2016_40489_33358.jpg

FS_ID:40489
DS_ID:21042
EP_NO: 15477
Repair Type: Non-Urgent
Crossing Status: Found
UCIP Comments: Stacey Boyd, LMA superintendent for RD0501, confirmed the removal and replacement of existing crossing under new permit no. 18811. New crossing will be a 30-inch diameter discharge pipe above the design flood plane. Construction will start soon. Update record once the project is completed. Dense vegetation on both waterside and landside. Recommend removing vegetation along pipe alignment to conduct proper inspection of structure and appurtenances. FIELD_STRUCT_DESC: 42-inch steel pipe through the levee, 6.5 feet below the crown. Siphon breaker on waterward slope. Pump on the landward side (Permit No. 15477, 1990). Pipe exposed along both slopes. (USACE-1959). This entry matches the Drainage or Irrigation Structure referenced in O&M manual (HLM 2.0).
FS Date: 6/7/2013

Overview of crown, looking downstream.

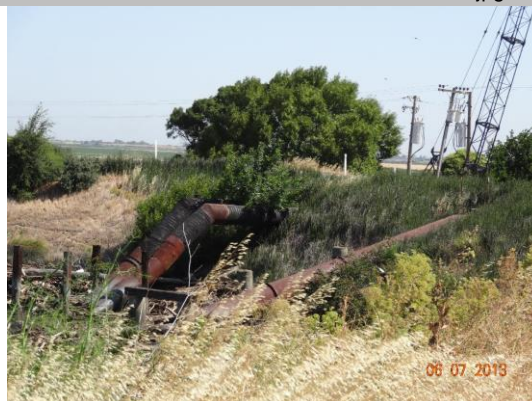
Photo 2 of 2 : UCIP_FA_2016_40489_33359.jpg

One 42-inch steel pile with siphon break on waterside slope.

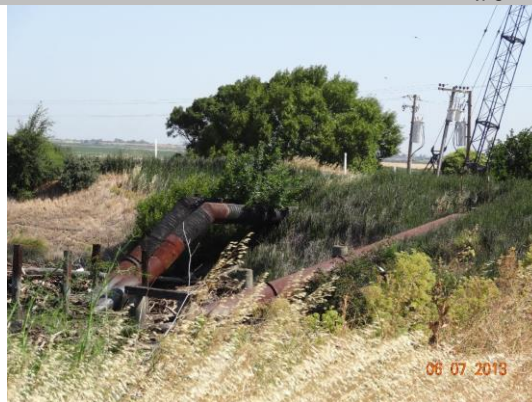
Photo 2 of 2 : UCIP_FA_2016_47049_33373.jpg

FS_ID:47049
DS_ID:21091
EP_NO: 15477
Repair Type: Non-Urgent
Crossing Status: Found
UCIP Comments: Dense vegetation limits the inspector's visibility to identify signs of pipe failure (leaks) through the slope. Recommend removing vegetation along pipe alignment to conduct proper inspection of structure and appurtenances.
FIELD_STRUCT_DESC: 2 of 2: 36-inch steel pipe through the levee, 7.0 feet below the crown. Siphon breaker on waterward shoulder. Pumps on landward side. Pipe exposed along both slopes. Pipe supports at levee shoulders, were cutoff walls from pre-existing pipe (Permit No. 15477-1990) Dual 36-inch pipes are approximately 36-inches apart.
FS Date: 6/7/2013

Overview of dual pipes on waterward side.

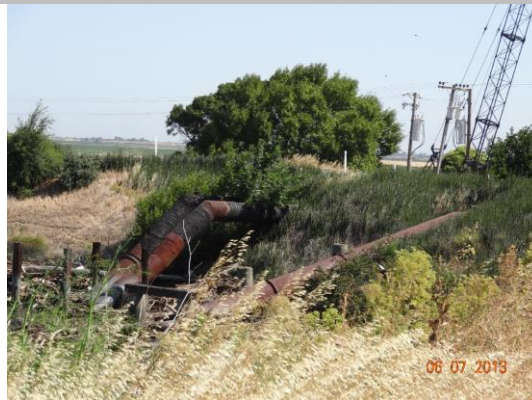
Photo 2 of 2 : UCIP_FA_2016_47050_33372.jpg

FS_ID:47050
DS_ID:21084
EP_NO: N/A
Repair Type: Non-Urgent
Crossing Status: Found
UCIP Comments: Dense vegetation limits the inspector's visibility to identify signs of pipe failure (leaks) through the slope. Recommend removing vegetation along pipe alignment to conduct proper inspection of structure and appurtenances.
FIELD_STRUCT_DESC: 2 of 2: 36-inch steel pipe through the levee, 7.0 feet below the crown. Siphon breaker on waterward shoulder. Pumps on landward side. Pipe exposed along both slopes. Pipe supports at levee shoulders, were cutoff walls from pre-existing pipe. (Permit No. 15477-1990) Pipes are approximately 36 inches apart.
FS Date: 6/7/2013

Overview of waterward side--3 crossings visible 1-42 inch pipe and 2-36 inch pipes.

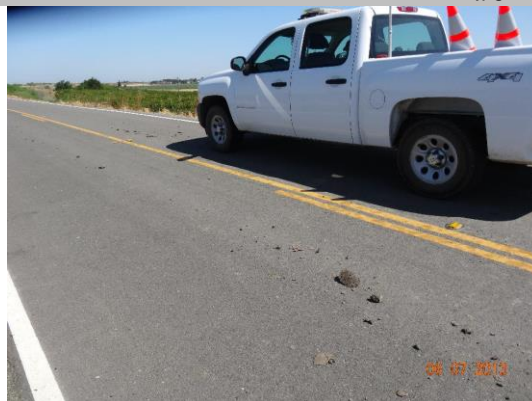
Photo 1 of 2 : UCIP_FA_2016_32537_58989.jpg

FS_ID:32537
DS_ID:21044
EP_NO: N/A
Repair Type: Non-Urgent
Crossing Status: Found
UCIP Comments: Dense vegetation limits the inspector's visibility to identify signs of pipe failure (leaks) through the slope. Recommend removing vegetation along pipe alignment to conduct proper inspection of structure and appurtenances.
FIELD_STRUCT_DESC: 14-inch steel pipe through the levee, 6.2 feet below the crown. Siphon breaker on waterward shoulder. (USACE-1959). This entry matches the Drainage or Irrigation Structure referenced in O&M manual (HLM 2.60). Pipe was repaired in 1984 under Permit No. 13937. The repair consisted of replacing the pipeline within the levee crown with new soil proofed steel pipe.
FS Date: 6/7/2013

View of levee crown--narrow road.

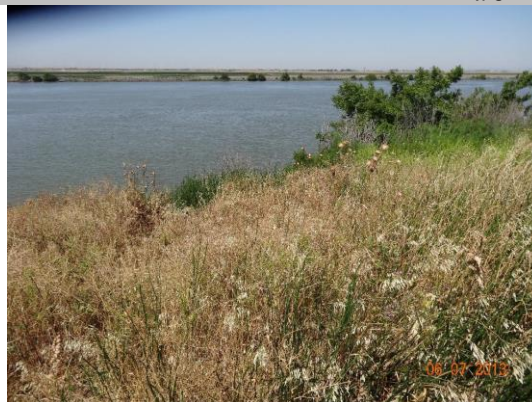
Photo 2 of 2 : UCIP_FA_2016_32537_58990.jpg

Photo taken just downstream of crossing looking at waterward side.

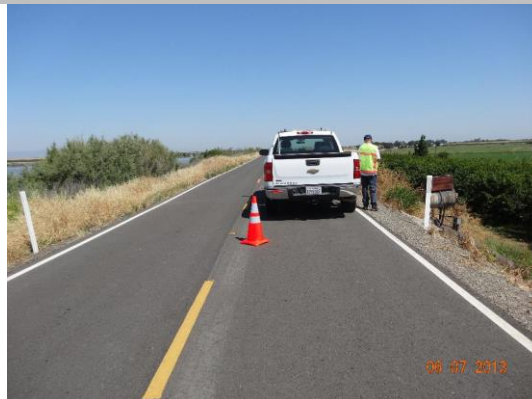
Photo 1 of 2 : UCIP_FA_2016_44872_33392.jpg

Comment Code					
Inspector Comment					
FS_ID:44872					
DS_ID:21045					
EP_NO: 4733					
Repair Type: Non-Urgent					
Crossing Status: Found					
UCIP Comments: Dense vegetation limits the inspector's visibility to identify signs of pipe failure (leaks) through the waterward slope.					
Recommend removing vegetation along pipe alignment to conduct proper inspection of structure and appurtenances.					
FIELD_STRUCT_DESC: 18-inch pipe through the levee, 4.0 feet below the crown. Cutoff wall around pipe at center of levee. Siphon breaker on apex of pipe at landward shoulder. Rock revetment on waterward slope.					
16-inch pipe welded to 18-inch pipe near landward shoulder, extends down landward slope. Pipe exposed along both slopes. (Permit No. 4733-1964)					
FS Date: 6/7/2013

View of levee crown at crossing.

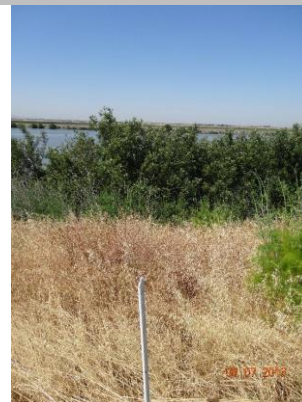
Photo 2 of 2 : UCIP_FA_2016_44872_33393.jpg

Dense vegetation hindered inspection on waterward side.

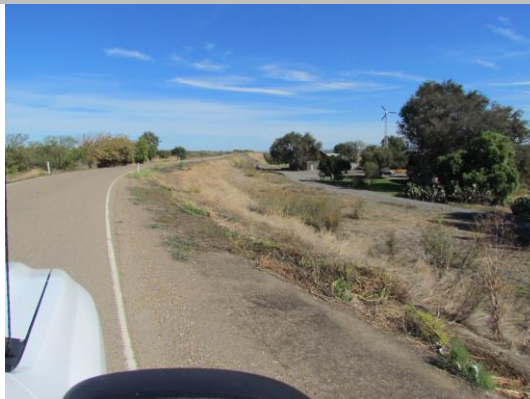
Photo 1 of 1 : FA_2016_RD0501_171_32_20161021_00068.jpg

LM Start	0.01	Rating **	A/W	Issue No.	32
LM End	7.70	Issue Type +	Ma	Location *	LS
Category	Earthen Levee			GPS Latitude/Longitude	
				Start	End
Item	Vegetation			38.228207 °	38.285530 °
				-121.673012 °	-121.606210 °
DWR ID	DWR_RD0501_03_f_2016_32				
Comment Code					
V1 : Control annual grass and weeds on the levee slopes and easements.					
Inspector Comment					
RD 501 has mowing crew on levee chopping the weeds on landside from levee mile 0.01-7.70 top and bottom of slope.

RD 501 Unit 3 looking downstream landside slope levee mile 0.01 -7.70.

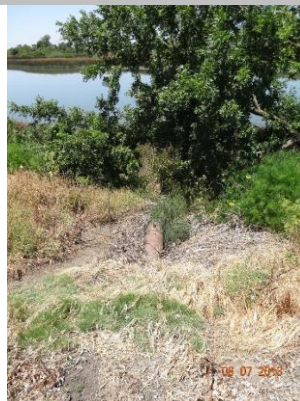
Photo 1 of 2 : UCIP_FA_2016_44873_33405.jpg

Comment Code					
Inspector Comment					
FS_ID:44873					
DS_ID:21065					
EP_NO: N/A					
Repair Type: Non-Urgent					
Crossing Status: Found					
UCIP Comments: Pump operating during inspection. Need to determine owner. Dense vegetation limits the inspector's visibility to identify signs of pipe failure (leaks) through the waterward slope. Recommend removing vegetation along pipe alignment to conduct proper inspection of structure and appurtenances.					
FIELD_STRUCT_DESC: 14-inch steel pipe through the levee, 6.3 feet below the crown instead of 16-inch pipe mentioned in O&M. Siphon breaker on landward slope. Pipe exposed on both slopes. (USACE-1959). This entry matches the Drainage or Irrigation Structure referenced in O&M manual (HLM 0.70).					
FS Date: 6/7/2013

Overview of waterward side. Dense vegetation limits proper inspection.

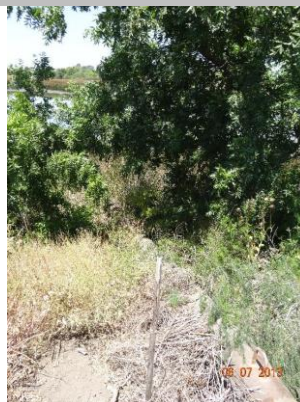
Photo 2 of 2 : UCIP_FA_2016_44873_33402.jpg

Conditions of waterward slope--dense vegetation along slope.

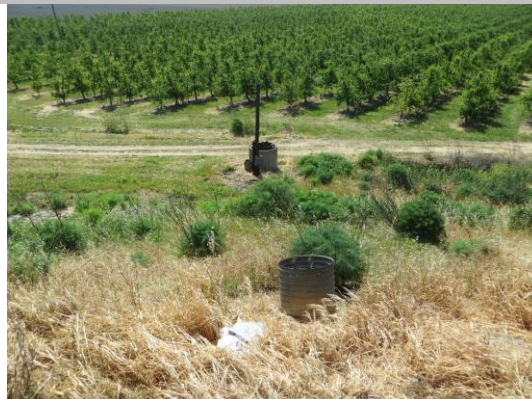
Photo 1 of 2 : UCIP_FA_2016_44728_73924.jpg

Comment Code					
Inspector Comment					
FS_ID:44728					
DS_ID:21066					
EP_NO: N/A					
Repair Type: Non-Urgent					
Crossing Status: Found					
UCIP Comments: Pipe appears abandoned and if so should be done so properly. Wooden walkway to pier in disrepair and a hazard.					
FIELD_STRUCT_DESC: 12-inch steel irrigation pipe through the levee, 8.0-feet below the crown. Siphon breaker on landward slope. Pump on pipe structure in stream. Concrete standpipe and distribution slide gates at landward toe. (USACE-1959). This entry matches the Drainage or Irrigation Structure referenced in O&M manual (HLM 1.50). 1.5-inch electrical conduit at same location.					
FS Date: 6/7/2013

Siphon breaker in 24-inch CMP riser on LS slope. Standpipe visible at LS toe.

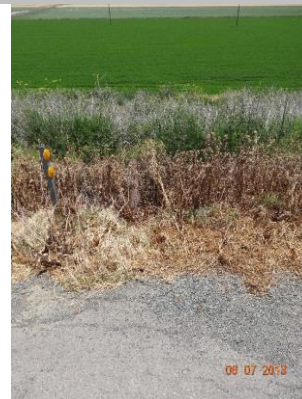
Photo 2 of 2 : UCIP_FA_2016_43503_33411.jpg

Item	DWR UCIP Field Study			38.249362 °	38.249362 °	
				-121.656357 °	-121.656357 °	
DWR ID						
Comment Code						
Inspector Comment						
FS_ID:43503 DS_ID:21068 EP_NO: N/A Repair Type: Non-Urgent Crossing Status: Found UCIP Comments: Authorized or Unauthorized? Need permit authorizing work. Dense vegetation limits the inspector's visibility to identify signs of pipe failure (leaks) through the slope on both waterward and landward side. Recommend removing vegetation along pipe alignment to conduct proper inspection of structure and appurtenances. FIELD_STRUCT_DESC: 10-inch steel pipe through the levee, 6.3 feet below the crown. Pump, gate valve and switch box on waterward slope. Originally reported as 3.8-feet below crown in O+M manual, 1959 at HLM: 2.0. FS Date: 6/7/2013

Overview of landward side. Pipe is visible however dense vegetation limits proper inspection.

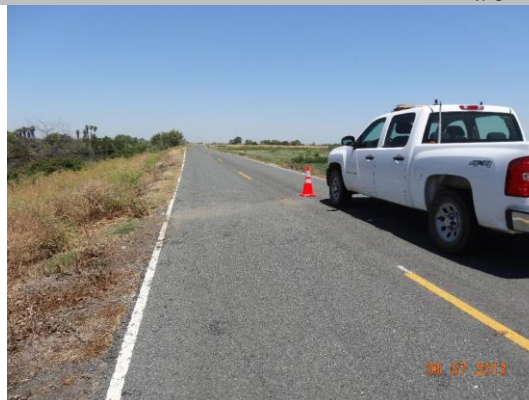
Photo 1 of 2 : UCIP_FA_2016_18945_31607.jpg

LM Start	2.52	Rating **	M	Issue No.	131
LM End	2.52	Issue Type +	En	Location *	WS
Category	Supplemental			GPS Latitude/Longitude	
				Start	End
Item	DWR UCIP Field Study			38.256255 °	38.256255 °
				-121.651551 °	-121.651551 °
DWR ID					
Comment Code					
Inspector Comment					
FS_ID:18945					
DS_ID:21047					
EP_NO: N/A					
Repair Type: Non-Urgent					
Crossing Status: Found					
UCIP Comments: Need to determine owner of structure. Recommend removing vegetation along pipe alignment to conduct proper inspection of structure and appurtenances.					
FIELD_STRUCT_DESC: 16-inch steel pipe through the levee, 3.3 feet below the crown. Gate valve and switch box on landward slope. Pipe exposed on both slopes. (USACE-1959) Riprap on waterward side. This entry matches the Drainage or Irrigation Structure referenced in O&M manual (HLM 2.70).					
FS Date: 6/7/2013

Overview of levee crown at crossing.

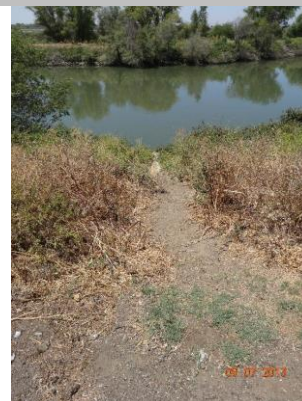
Photo 2 of 2 : UCIP_FA_2016_18945_31609.jpg

Overview of waterward side. Pipe is mostly buried through waterward side.

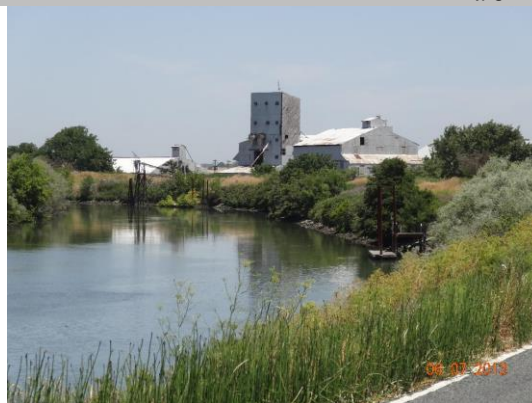
Photo 1 of 2 : UCIP_FA_2016_32538_58994.jpg

Comment Code					
Inspector Comment					
FS_ID:32538					
DS_ID:21048					
EP_NO: N/A					
Repair Type: Non-Urgent					
Crossing Status: Found					
UCIP Comments: Dense vegetation limits the inspector's visibility to identify signs of pipe failure (leaks) through the waterward slope. Recommend removing vegetation along pipe alignment to conduct proper inspection of structure and appurtenances. Need to find owner of crossing and determine if permit number is available.					
FIELD_STRUCT_DESC: 12-inch steel pipe through the levee, 5.0 feet below the crown. Pump on pile structure in stream. Service pole on landward slope. Concrete standpipe at landward toe. (USACE-1959). This entry matches the Drainage or Irrigation Structure referenced in O&M manual (HLM 3.80).					
FS Date: 6/7/2013

Photo taken downstream of structure.

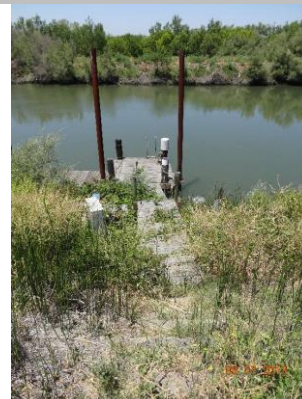
Photo 2 of 2 : UCIP_FA_2016_32538_58999.jpg

View of waterward side. Dense vegetation throughout waterward side. Walkway visible and support piles.

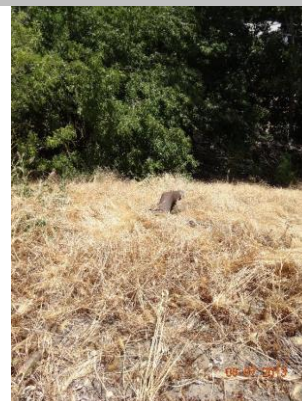
Photo 1 of 2 : UCIP_FA_2016_46768_30382.jpg

Comment Code					
Inspector Comment					
FS_ID:46768					
DS_ID:21049					
EP_NO: 1557					
Repair Type: Non-Urgent					
Crossing Status: Found					
UCIP Comments: Crossing appears abandoned--wooden platform structure appears to be abandoned on waterward side. Small hole underneath pipe on landward side--unable to determine cause (rodent/pipe leak) Need to find owner of crossing to determine status. Recommend removing vegetation along pipe alignment to conduct proper inspection of structure and appurtances.					
FIELD_STRUCT_DESC: *ABANDONED* 6-inch pipe through the levee, 2.5 feet below the crown. Pump in pump house on waterward slope. (USACE-1959). This entry matches the Drainage or Irrigation Structure referenced in O&M manual (HLM 3.90). Permit No. 1557, 1951).					
FS Date: 6/7/2013

View of landward side showing a small section of pipe exposed.

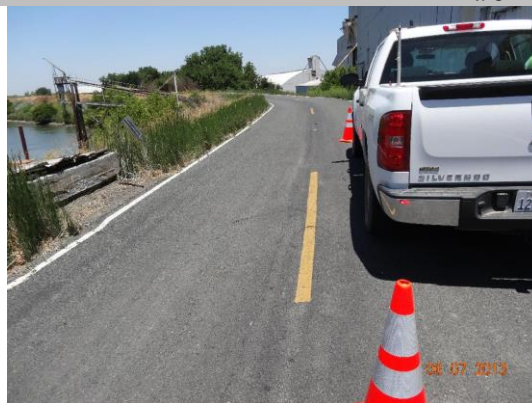
Photo 1 of 2 : UCIP_FA_2016_32540_59007.jpg

LM Start	3.65	Rating **	M	Issue No.	136
LM End	3.65	Issue Type +	En	Location *	LS
Category	Supplemental			GPS Latitude/Longitude	
				Start	End
Item	DWR UCIP Field Study			38.267818 °	38.267818 °
				-121.640521 °	-121.640521 °
DWR ID					
Comment Code					
Inspector Comment					
FS_ID:32540 DS_ID:21050 EP_NO: N/A Repair Type: Non-Urgent Crossing Status: Found UCIP Comments: Unable to properly inspect structure--limited access. Also unable to determine if structure is still in use. Levee logs indicate this crossing is abandoned. If strcture is no longer used-how to prevent water from flowing through levee during flood season. If structure no longer in use owner will need to coordinate with CVFPB. FIELD_STRUCT_DESC: *ABANDONED* 5.5 x 5.5 foot concrete tunnel through the levee, 6.5 feet below the crown. FS Date: 6/7/2013

View of narrow levee crown.

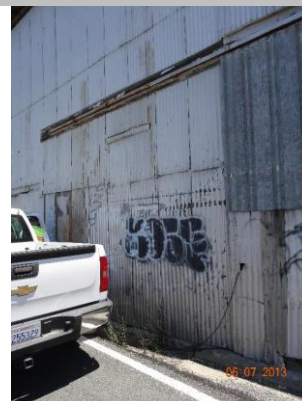
Photo 2 of 2 : UCIP_FA_2016_32540_59006.jpg

View of large building structure located on landward side.

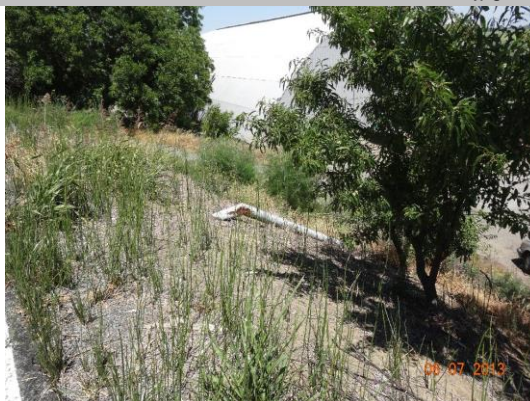
Photo 2 of 2 : UCIP_FA_2016_43524_33424.jpg

LM Start	3.70	Rating **	M	Issue No.	151 (cont)	
LM End	3.70	Issue Type +	En	Location *	LS	
Category	Supplemental			GPS Latitude/Longitude		
				Start		End
Item	DWR UCIP Field Study			38.268570 °		38.268570 °
				-121.640408 °		-121.640408 °
DWR ID						
Comment Code						
Inspector Comment						
FS_ID:43524 DS_ID:21053 EP_NO: N/A Repair Type: Non-Urgent Crossing Status: Found UCIP Comments: Dense vegetation limits the inspector's visibility to identify signs of pipe failure (leaks) through the waterward slope. Recommend removing vegetation along pipe alignment to conduct proper inspection of structure and appurtenances. FIELD_STRUCT_DESC: 6-inch pipe through the levee, 2.5 feet below the crown. Pump in pump house on waterward slope. (USACE-1959). This entry matches the Drainage or Irrigation Structure referenced in O&M manual (HLM 4.00). (Permit No. 1557, 1951). FS Date: 6/7/2013

View of landward side. Pipe visible.

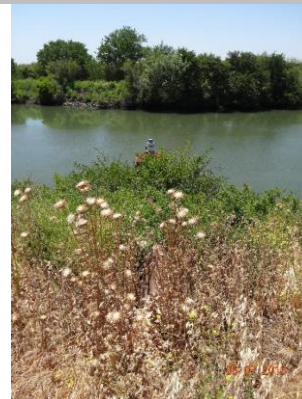
Photo 1 of 2 : UCIP_FA_2016_32541_59008.jpg

View of waterward side. Pump located on pile structure in stream.

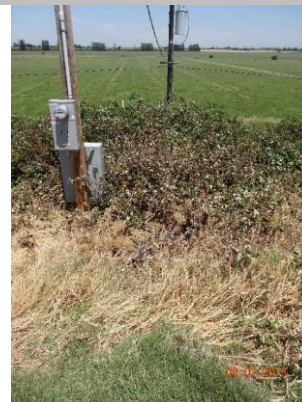
Photo 2 of 2 : UCIP_FA_2016_32541_59009.jpg

View of landward side. Power source and control box on landward side.

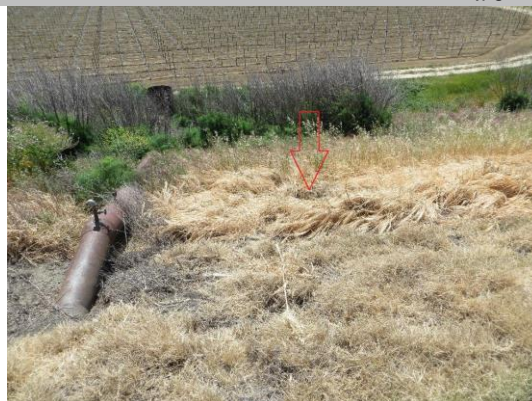
Photo 1 of 2 : UCIP_FA_2016_44877_73946.jpg

FS_ID:44877
DS_ID:21055
EP_NO: N/A
Repair Type: Non-Urgent
Crossing Status: Found
UCIP Comments: Pipe abandoned and should be done so properly.
FIELD_STRUCT_DESC: 10-inch steel irrigation pipe through the levee, 1.8-feet below the crown. Pump on pile structure in stream. Pipe exposed on landward side. (USACE-1959). This entry matches the Drainage or Irrigation Structure referenced in O&M manual (HLM 5.90).
FS Date: 4/23/2015

Buried pipe exposed in trench 8-feet downstream from visible pipe.

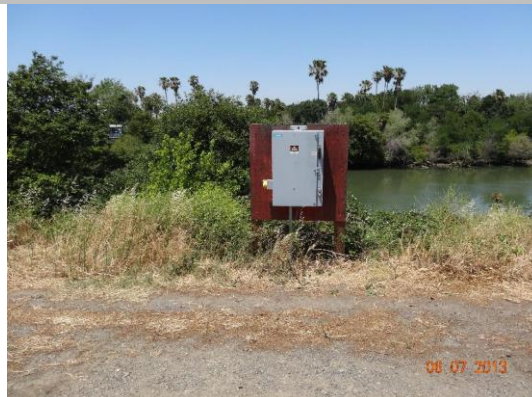
Photo 1 of 2 : UCIP_FA_2016_19666_33435.jpg

LM Start	5.43	Rating **	M	Issue No.	133
LM End	5.43	Issue Type +	En	Location *	LS
Category	Supplemental			GPS Latitude/Longitude	
				Start	End
Item	DWR UCIP Field Study			38.288950 °	38.288950 °
				-121.644183 °	-121.644183 °
DWR ID					
Comment Code					
Inspector Comment					
FS_ID:19666 DS_ID:21054 EP_NO: N/A Repair Type: Non-Urgent Crossing Status: Found UCIP Comments: Need to find owner and permit number authorizing work. Dense vegetation limits the inspector's visibility to identify signs of pipe failure (leaks) along the waterward and landward slopes. Recommend removing vegetation along pipe alignment to conduct proper inspection of structure and appurtenances. FIELD_STRUCT_DESC: 12-inch pipe through the levee, 3.0 feet below the crown. Pump on pile structure in stream. FS Date: 6/7/2013

Overview of waterward side. Control box located near levee crown.

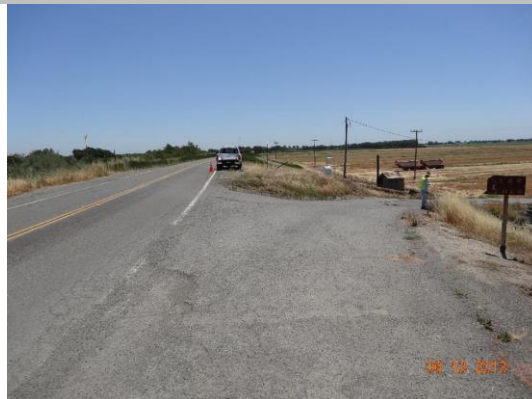
Photo 1 of 2 : UCIP_FA_2016_32542_59022.jpg

Comment Code					
Inspector Comment					
FS_ID:32542 DS_ID:21059 EP_NO: N/A Repair Type: Non-Urgent Crossing Status: Found UCIP Comments: Need to determine status of crossing. Horizontal and vertical cracks present on stand pipe located on landward side. Dense vegetation limits the inspector's visibility to identify signs of pipe failure (leaks) along the waterward slope. Recommend removing vegetation along pipe alignment to conduct proper inspection of structure and appurtenances. FIELD_STRUCT_DESC: 12-inch steel pipe through the levee, 6.0 feet below the crown. 2-inch conduit line through levee. Pump and gate valve on waterward slope. Pipe exposed on landward side. (USACE-1959). This entry matches the Drainage or Irrigation Structure referenced in O&M manual (HLM 6.90). FS Date: 6/13/2013

Overview of levee crown at crossing.

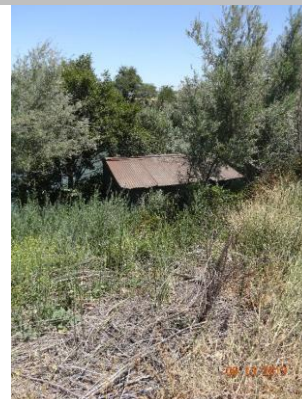
Photo 2 of 2 : UCIP_FA_2016_32542_59023.jpg

View of waterward side. Dense vegetation along levee slope.

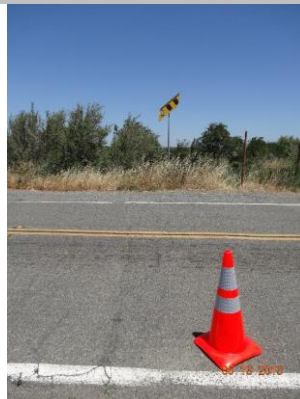
Photo 1 of 2 : UCIP_FA_2016_42118_72902.jpg

LM Start	6.40	Rating **	M	Issue No.	146
LM End	6.40	Issue Type +	En	Location *	LS
Category	Supplemental			GPS Latitude/Longitude	
				Start	End
Item	DWR UCIP Field Study			38.290356 °	38.290356 °
				-121.627488 °	-121.627488 °
DWR ID					
Comment Code					
Inspector Comment					
FS_ID:42118 DS_ID:24054 EP_NO: N/A Repair Type: Non-Urgent Crossing Status: Indicator Found UCIP Comments: Need to determine encroachment number issued for pipe installation. FIELD_STRUCT_DESC: Gasline through levee at an angle with unknown depth. Markers visible on both sides. FS Date: 6/13/2013

Markers visible on waterward side.

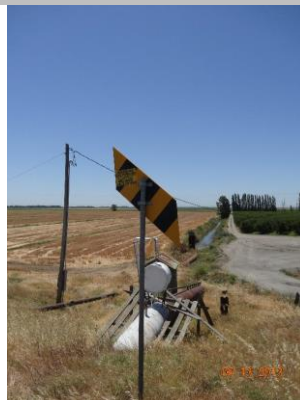
Photo 2 of 2 : UCIP_FA_2016_42118_72901.jpg

Marker visible on landward side.

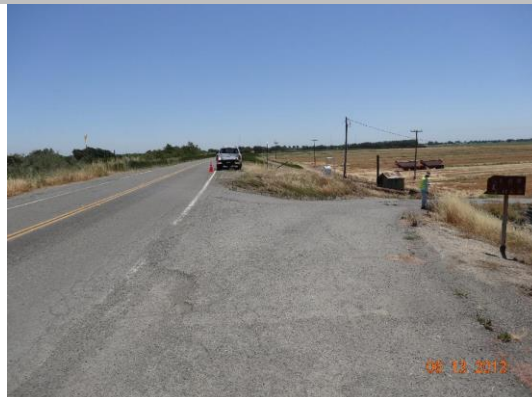
Photo 1 of 2 : UCIP_FA_2016_19668_33446.jpg

FS_ID:19668
DS_ID:21057
EP_NO: N/A
Repair Type: Non-Urgent
Crossing Status: Found
UCIP Comments: Crossing was operating during inspection; Dense vegetation limits the inspector's visibility to identify signs of pipe failure (leaks) along the waterward slope. Recommend removing vegetation along pipe alignment to conduct proper inspection of structure and appurtenances.
FIELD_STRUCT_DESC: 1 of 2: 30-inch steel pipe through the levee, 9.5 feet below the crown. Cutoff wall around pipe at center of levee. Siphon breaker at landward slope. Primer tanks on landward slope. Pipe exposed on both slopes. This entry matches the Drainage or Irrigation Structure referenced in O&M manual (HLM 6.90). Pipe installed under Permit No. 611 in 1934. Section of pipe between shoulders removed and replaced with 30-inch steel pipe under Permit No. 2497 (1959).
FS Date: 6/13/2013

Overview of levee crown--multiple crossings within a 50 foot stretch.

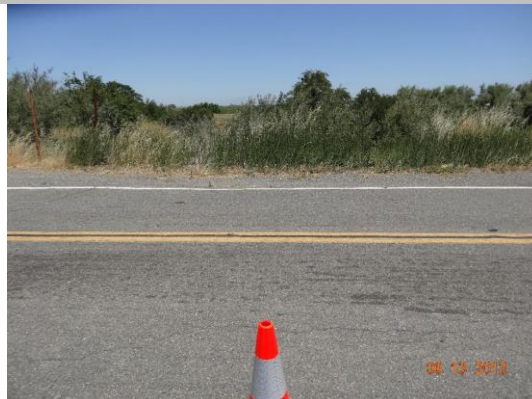
Photo 2 of 2 : UCIP_FA_2016_32543_59027.jpg

FS_ID:32543
DS_ID:21058
EP_NO: N/A
Repair Type: Non-Urgent
Crossing Status: Found
UCIP Comments: Dense vegetation limits the inspector's visibility to identify signs of pipe failure (leaks) along the waterward slope. Recommend removing vegetation along pipe alignment to conduct proper inspection of structure and appurtenances. Need to find pipe owner. Unable to determine status of crossing.
FIELD_STRUCT_DESC: Abandoned 8-inch steel pipe through the levee, 2.7 feet below the crown. Siphon breaker on apex of pipe at landward shoulder. Surge chamber at landward toe. Pump near waterward toe. Pipe exposed on landward side. (USACE-1959). Concrete platform 4 feet by 3 feet located on landward toe. 3-inch conduit runs along 8-inch steel pipe. This entry matches the Drainage or Irrigation Structure referenced in O&M manual (HLM 6.90).
FS Date: 6/13/2013

View levee crown at crossing.

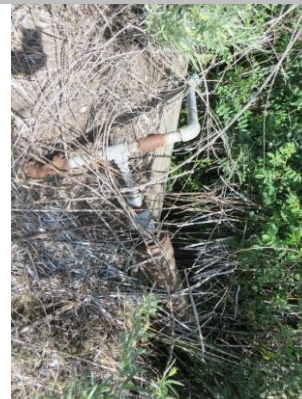
Photo 1 of 2 : UCIP_FA_2016_44748_73948.jpg

LM Start	6.41	Rating **	M	Issue No.	148
LM End	6.41	Issue Type +	En	Location *	LS
Category	Supplemental			GPS Latitude/Longitude	
				Start	End
Item	DWR UCIP Field Study			38.290356 °	38.290356 °
				-121.627349 °	-121.627349 °
DWR ID					
Comment Code					
Inspector Comment					
FS_ID:44748					
DS_ID:21027					
EP_NO: N/A					
Repair Type: Non-Urgent					
Crossing Status: Found					
UCIP Comments: Pipe appears abandoned and if so should be done so properly.					
FIELD_STRUCT_DESC: 2 of 2: 4-inch steel pipe through the levee, 7.3 feet below the crown. (USACE-1959). Pipe visible on upstream side of wooden platform of WS slope. This entry matches the Drainage or Irrigation Structure referenced in O&M manual (HLM 6.90).					
FS Date: 4/23/2015

4-inch pipe connected to smaller galvanized iron pipe on WS slope.

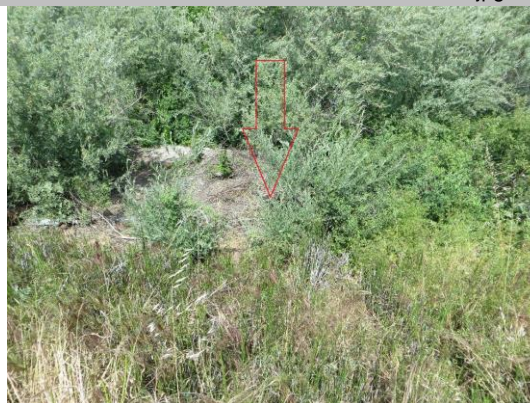
Photo 2 of 2 : UCIP_FA_2016_44748_73947.jpg

Pipe visible on upstream side of wooden platform on the WS slope.

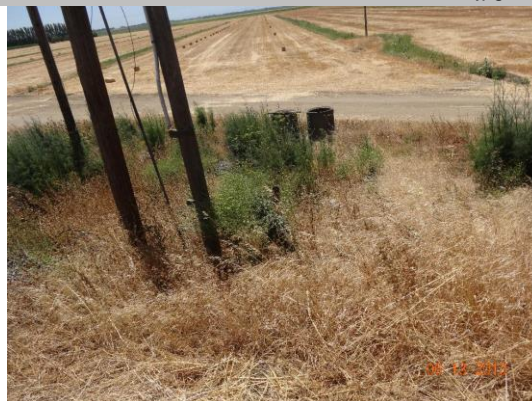
Photo 2 of 2 : UCIP_FA_2016_32544_59033.jpg

Item	DWR UCIP Field Study			38.290130 °		38.290130 °
				-121.620168 °		-121.620168 °
DWR ID						
Comment Code						
Inspector Comment						
FS_ID:32544						
DS_ID:21060						
EP_NO: N/A						
Repair Type: Non-Urgent						
Crossing Status: Found						
UCIP Comments: Dense vegetation limits the inspector's visibility to identify signs of pipe failure (leaks) along the slope. Recommend removing vegetation along pipe alignment to conduct proper inspection of structure and appurtenances. Walkway missing but platform remain on the waterward side.						
FIELD_STRUCT_DESC: 12-inch pipe through the levee, 6.5 feet below the crown. Switch panel on waterward slope. Pump on pile structure in stream. (USACE-1959). This entry matches the Drainage or Irrigation Structure referenced in O&M manual (HLM 7.30).						
FS Date: 6/13/2013

View of standpipes located on landward side.

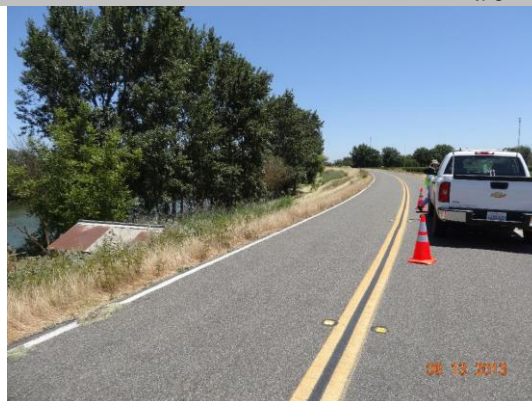
Photo 1 of 2 : UCIP_FA_2016_46834_33471.jpg

UCIP Comments: 11/19/2015 DWR Inspector (H. Phillips) coordinated with LMA superintendent and the owner for this crossing is Walter Koeing, APN No. 042220040. According to LMA superintendent owner installed filter system with fence on landward side and fence around pump in 2012. Pipe not replaced in 2012, this pipe would be a good candidate for internal inspection since the installation date for this crossing was recorded as 1946.06/13/2013 Conduit visible on landward side; new gate on WS toe; filtration system with security fence; Pipe has been upgraded--need permit authorizing work and owner. Dense vegetation limits the inspector's visibility to identify signs of pipe failure (leaks) along the waterward slope. Recommend removing vegetation along pipe alignment to conduct proper inspection of structure and appurtenances.

Overview of levee crown.

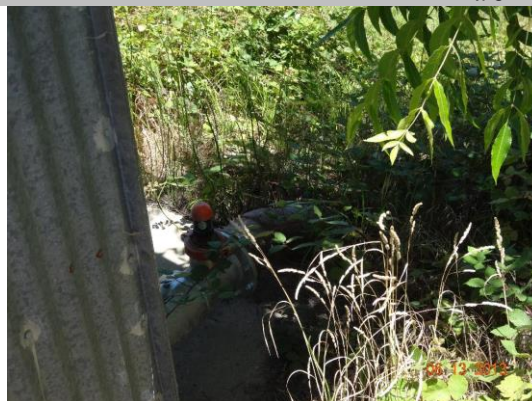
Photo 2 of 2 : UCIP_FA_2016_46834_33468.jpg

Pipe connection after pump station.

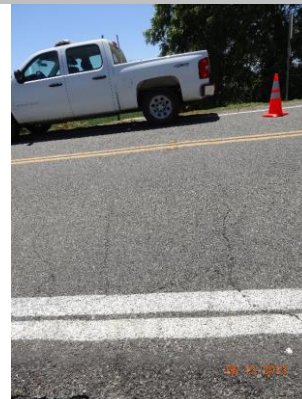
Photo 1 of 2 : UCIP_FA_2016_50025_59039.jpg

Comment Code					
Inspector Comment					
FS_ID:50025 DS_ID:21063 EP_NO: 11812 Repair Type: Non-Urgent Crossing Status: Found UCIP Comments: 8/22/2016 Crossing has been downgraded from Urgent to Non-Urgent no levee damage appears to be present along pipe alignment. There appears to be an erosion site adjacent to this crossing. Need to coordinate with DWR Inspectors. (DWR UCIP - omagana)6/07/2013 Open cut section of levee on LS slope 8 foot wide--repair work needed. Abandoned pump on waterward berm. Dense vegetation--Recommend removing vegetation along pipe alignment to conduct proper inspection of structure and appurtenances on waterward side. (DWR UCIP - omagana) FIELD_STRUCT_DESC: 14-inch steel pipe and 1.25-inch electrical conduit through the levee, both 3.0 feet below the crown. Cutoff wall around pipe and conduit at center of levee. Siphon breaker on apex of pipe at landward shoulder. Slant pump on waterward slope. Discharge structure at landward toe. Rock revetment on waterward slope. (Permit No. 11812-1976) FS Date: 8/22/2016

View of levee crown at crossing.

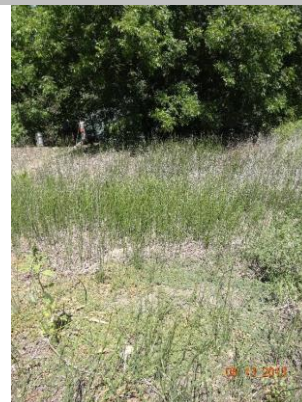
Photo 2 of 2 : UCIP_FA_2016_50025_59042.jpg

View of WS--pump located at the berm edge.

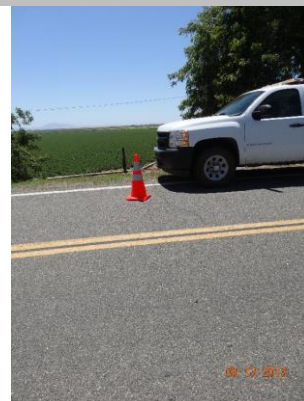
Photo 1 of 2 : UCIP_FA_2016_32546_59047.jpg

Comment Code					
Inspector Comment					
FS_ID:32546 DS_ID:21064 EP_NO: N/A Repair Type: Non-Urgent Crossing Status: Found UCIP Comments: Debris (pipe section) located on waterward berm. Dense vegetation limits the inspector's visibility to identify signs of pipe failure (leaks) along the waterward slope. Recommend removing vegetation along pipe alignment to conduct proper inspection of structure and appurtenances. FIELD_STRUCT_DESC: 8-inch steel pipe through the levee, 2.7 feet below the crown. Pump in pump house at landward toe. (USACE-1959). This entry matches the Drainage or Irrigation Structure referenced in O&M manual (HLM 8.20). FS Date: 6/13/2013

View of levee crown at crossing.

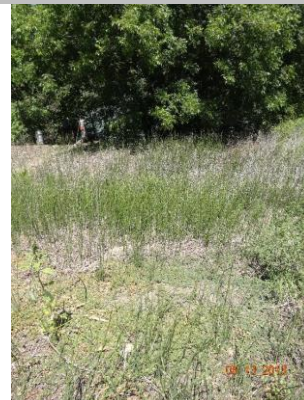
Photo 2 of 2 : UCIP_FA_2016_32546_59048.jpg

View of waterward side--dense vegetation limits visibility of 8-inch steel pipe. Pump belongs to another crossing.
